FINAL REPORT

FIELD RECONNAISSANCE AND  
WETLAND ASSESSMENT OF THE  
LEEDS SILVER SITE  
LEEDS, UTAH

JULY 1992

Mark D. Sprenger, Ph.D.  
Environmental Response Team

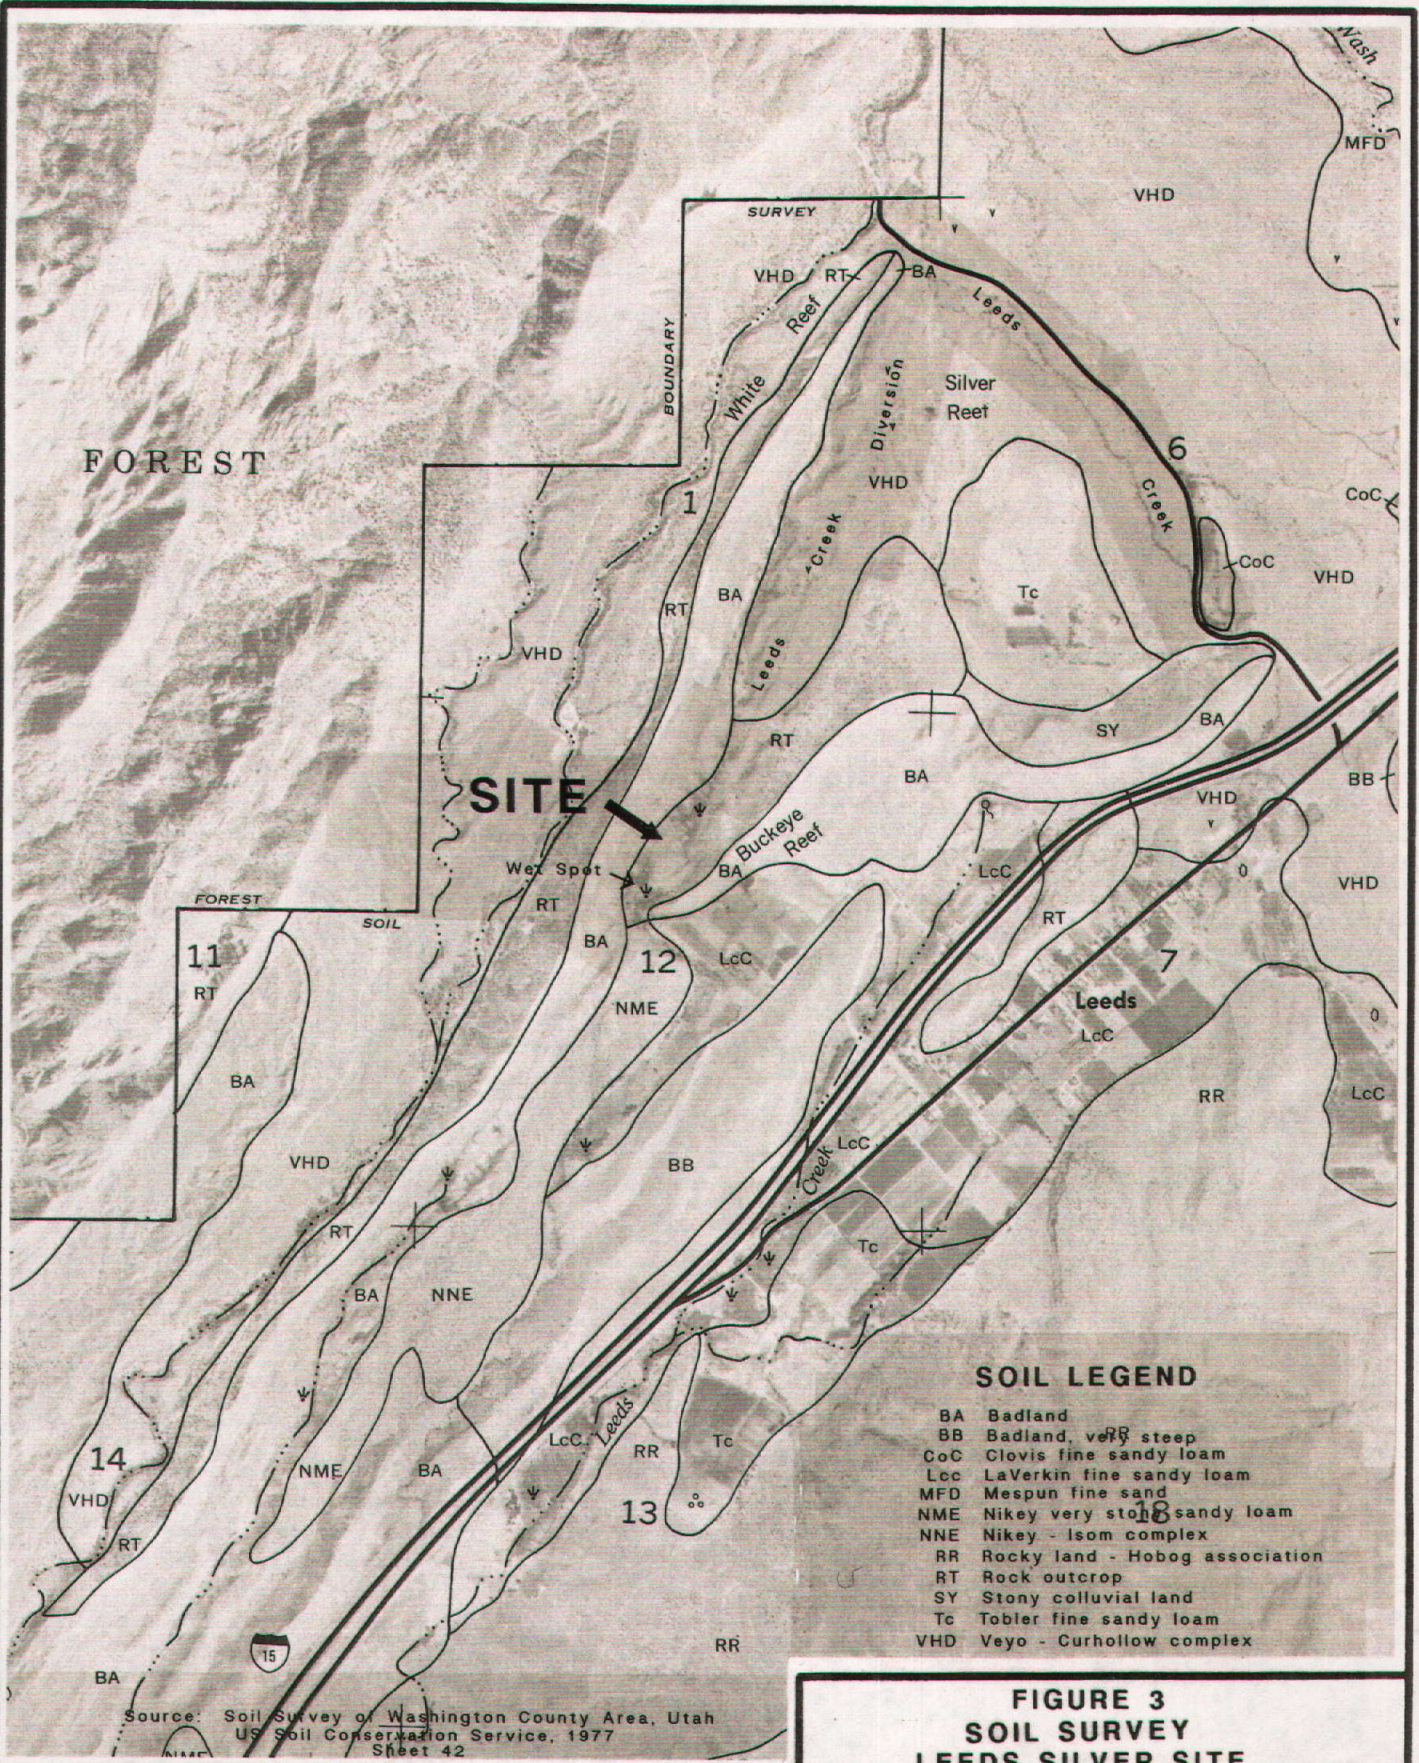
**FIGURE 3**  
**SOIL SURVEY**  
**LEEDS SILVER SITE**  
**LEEDS, UTAH**

The site has been mapped by the SCS as part of the rock outcrop-rock land association.<sup>(3)</sup> This association is present on gently sloping to very steep desert basins and on uplands and consists of bare bedrock, and very shallow soils over bedrock. The rock outcrop-rock land association is typically found at elevations ranging from 2,600 feet to 7,000 feet. The Leeds Silver Site is mapped as the rock outcrop unit (Figure 3). This mapping unit consists of bare bedrock exposures comprised of mostly sandstone, limestone, conglomerate, or basalt. Field investigation confirmed the presence of rock outcrop throughout most of the site. However, the soil in the wetland basin south of the collection and overflow ponds are not consistent with the description of the mapping unit. Within the basin the soils consist of a 6 to 14 inch layer of yellowish red to reddish brown fine sandy clay loam over dark gray sandy clay loam. A hardpan is present at 18 to 24 inches below the soil and consists of a reddish brown prismatic material. This relatively impervious layer could account for the saturated soil conditions observed throughout the basin.

The mapping performed by the SCS is based on aerial photography at a scale of 1:20,000 which prohibits the identification of small nontypical inclusions located within larger mapping units. Although the soil observed in the basin may represent an inclusion of an associated soil type, field observations suggests that this material was formed under different conditions and/or derived from a different parent material. The area north of the site is mapped as Veyo-Curhollow soils. The Veyo soils consist of brown cobbly sandy loam underlain by brown cobbly clay loam, yellowish-red and reddish-brown very cobbly clay and brown very cobbly sandy clay loam. The Curhollow soils consist of brown gravelly fine sandy loam overlaying light-brown gravelly loam and very gravelly fine sandy loam. The erosion hazard of this complex is moderate and the slopes range from 3 to 10 percent. The canal that drains Leeds Creek flows through the Veyo-Curhollow mapping unit and soil eroded from adjacent areas are likely to

enter this watercourse. Subsequent downstream transport and deposition in the wetland basin may account for the characteristics of the surface soil observed.
